City of DETROIT, MICHIGAN

VULNERABILITY OF

GAS UTILITIES

TO NUCLEAR ATTACK

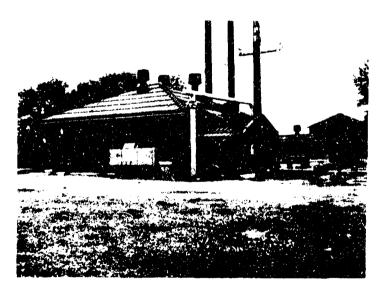
About one-half mile of open space intervenes between the station and the Ford Motor River Rouge

Figure 11. Regulator Building with Master Valve and Office Buildings in background looking away from direction of G. Z.

- 2. Bring into River Rouge Station a 50 psi supply regulated at undamaged Willow Station.
- 3. Route the emergency supply to the selected outgoing Transfer mains by using bypasses around the damaged regulators.

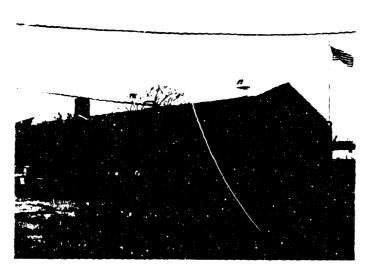
Allen Road Storehouse with Office-Garage at right. Blast strikes building front 9 degrees from head-on.

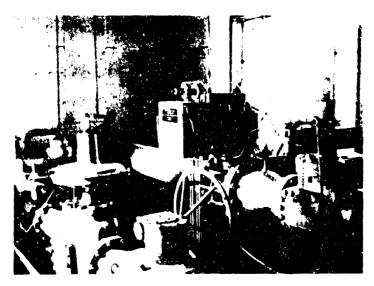
Portion of front of Station Building. Regulator Building is in left rear, Uniroyal tire plant in background. Looking in direction away from ground zero.

Interior of Regulator Building showing Regulators and Hi-Low Operators. Looking towards ground zero.

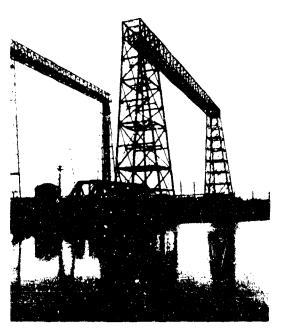
DAMAGE APPRAISAL NO. 17—PIPELINE BRIDGE HIVER ROUGE—ZUG ISLAND

Figure 24. Pipeline Bridge Direction is away from G. Z.
